HISTORIC STRUCTURE REPORT:
THE CUSTOM HOUSE AND TOWER

VOLUME II:
EXISTING CONDITIONS AND RECOMMENDATIONS

SARA B. CHASE
and
ANNE A. GRADY

SOCIETY FOR THE PRESERVATION OF
NEW ENGLAND ANTIQUITIES
CONSERVATION CENTER

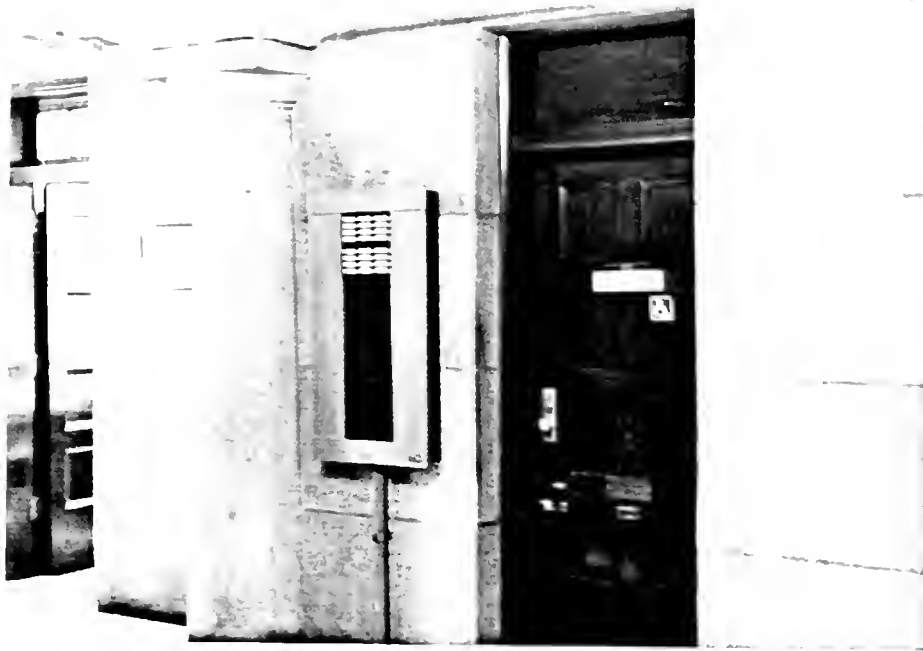
23 - View on the basement floor showing typical placement of signs on the walls, metal door (Peabody and Stearns) painted with wood graining, typical of those throughout the building.
